Manhole Inspection Summary

Manhole # S15Q__001MH

Insp Date: **12/9/08 2:51 PM**

Location Address: **2780 WILKENS AV**

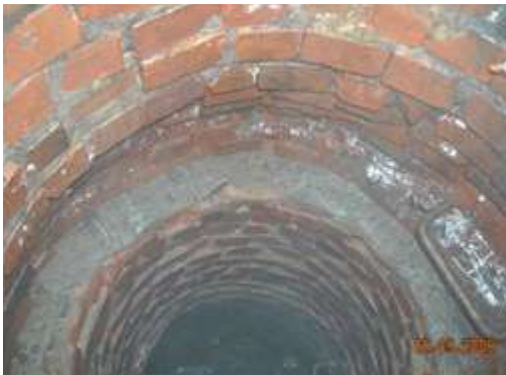
Comments **CHIMNEY/CORBEL OFFSET 3 INCHES EVENLY AROUND.**

CORBEL/CHIMNEY OFFSET

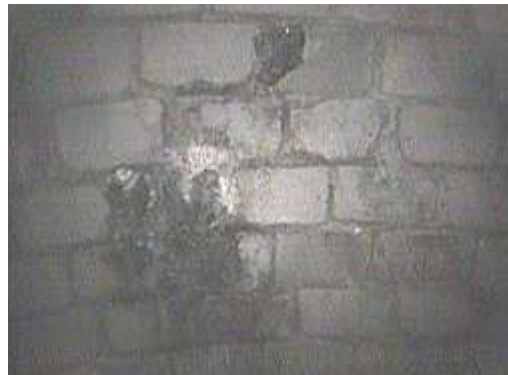
Defect 5

Infiltration: ☐ None ☐ Joint ☐ Cracks ☐ Mortar ☐ Roots ☒ **Wall**

INFILTRATION @ BARREL WALL

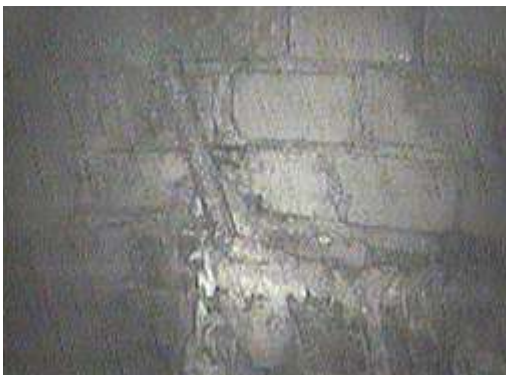
Defect 4

Surcharge ☒ **Evidence Of Surcharge** Depth: **4** (ft.) ☐ Active Surcharge Present

SURCHARGE EVIDENCE

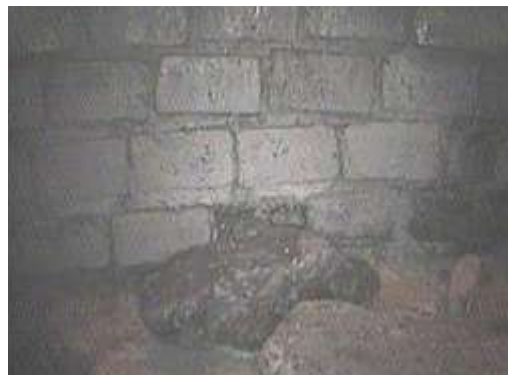
Defect 3

Condition: ☐ Sound ☐ Cracked ☐ Root Intrusion ☐ Deteriorated ☐ Leaks ☒ **Debris**

DEBRIS ON BENCH

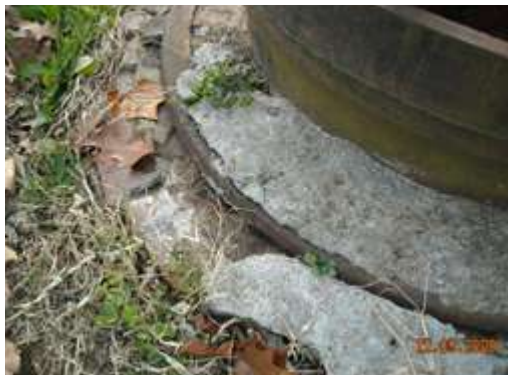
Defect 2

Frame Offset: **1.5** (in.) Condition: ☐ Sound ☐ Cracked ☒ **Leaks**

FRAME LEAKS

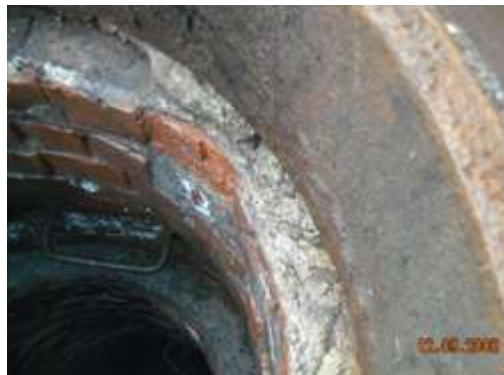
Defect 1

FRAME OFFSET

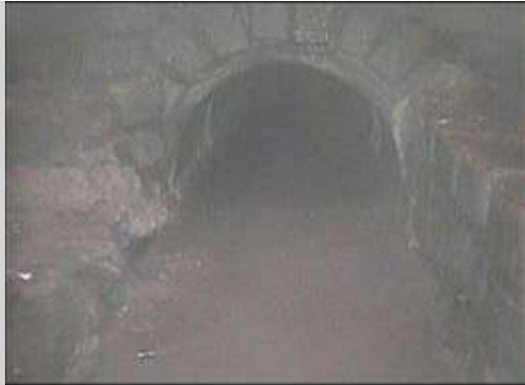
12 O'Clock Outflow

Pipe Height: **15.6** (in.) Rod and Bar (Angled)
Pipe Material: **Clay** ☐ Pipe Lined
Invert Depth: **14.30** (ft.) Flow Characteristics: **Slow**
Deposits: ☒ None ☐ Mud ☐ Sludge ☐ Debris ☐ Grease
Silt Depth: **0** (in.) Deposits Extent:
Infiltration: **Evidence** Pipe Seal Cond: **Sound**

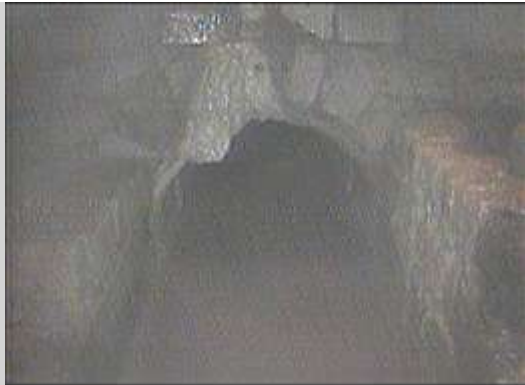
6 O'Clock Inflow

Infiltration: **Dripper** Pipe Seal Cond: **Unknown**

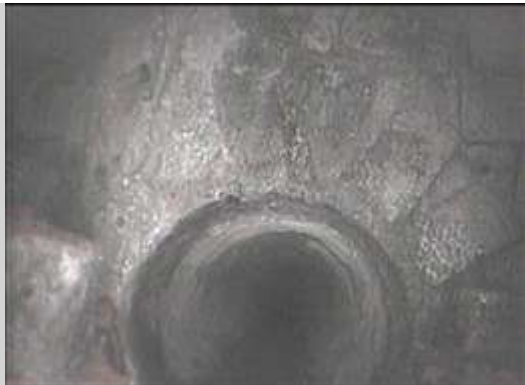
9 O'Clock Inflow

Deposits: ☐ None ☐ Mud ☐ Sludge ☐ Debris ☒ Grease

Silt Depth: **1** (in.) Deposits Extent: **Light**

Infiltration: **Evidence** Pipe Seal Cond: **Unknown**
